Technical Bulletin No. TB251208-1

Title: Correcting Incorrect Wiring of Blue Wire on the BAR6 – Units Labeled Service Code 38

Date: December 8, 2025

Affected Units: BAR6 Series - Service Code Beginning with 38

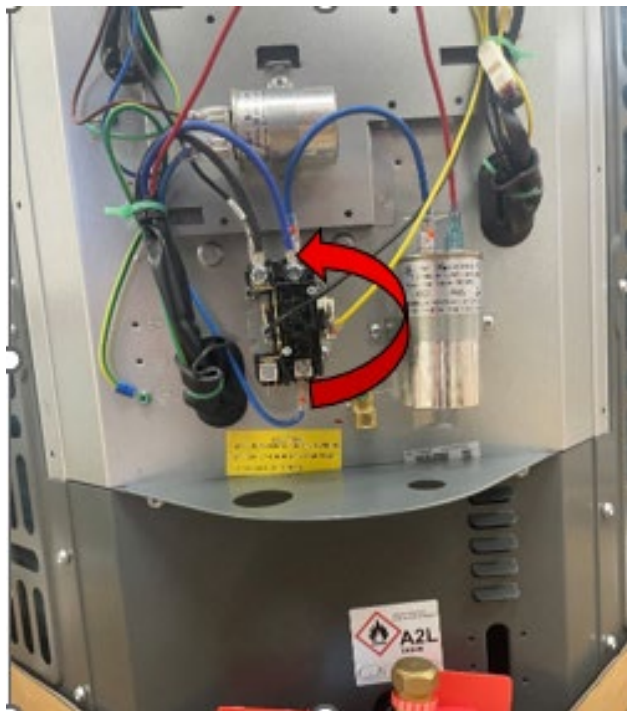
BAR6 units with **Service Code beginning with 38** due to a **factory wiring error**: the **blue wire is connected to the L2 terminal** instead of the correct **T2 terminal**.

1. **Locate the blue wire** currently connected to the L2 terminal.
2. **Carefully remove** the blue wire from the L2 terminal.
3. **Reconnect the blue wire** to the correct **T2 terminal**, as shown in the image below.
4. **Double-check all connections** for accuracy.
5. **Apply power** and verify that the unit operates normally.
